ENGINEERING REPORT

Insured: Nancy McNeil
Loss Location: Medford, MA
Date of Loss: October 11, 2001
Policy No.: HO12016316
Claim No.: Unknown
EFI File No.: 94507 - 17807

PROCTOR-SILEX TOASTER AND KELLOGG'S FROSTED STRAWBERRY POP-TART

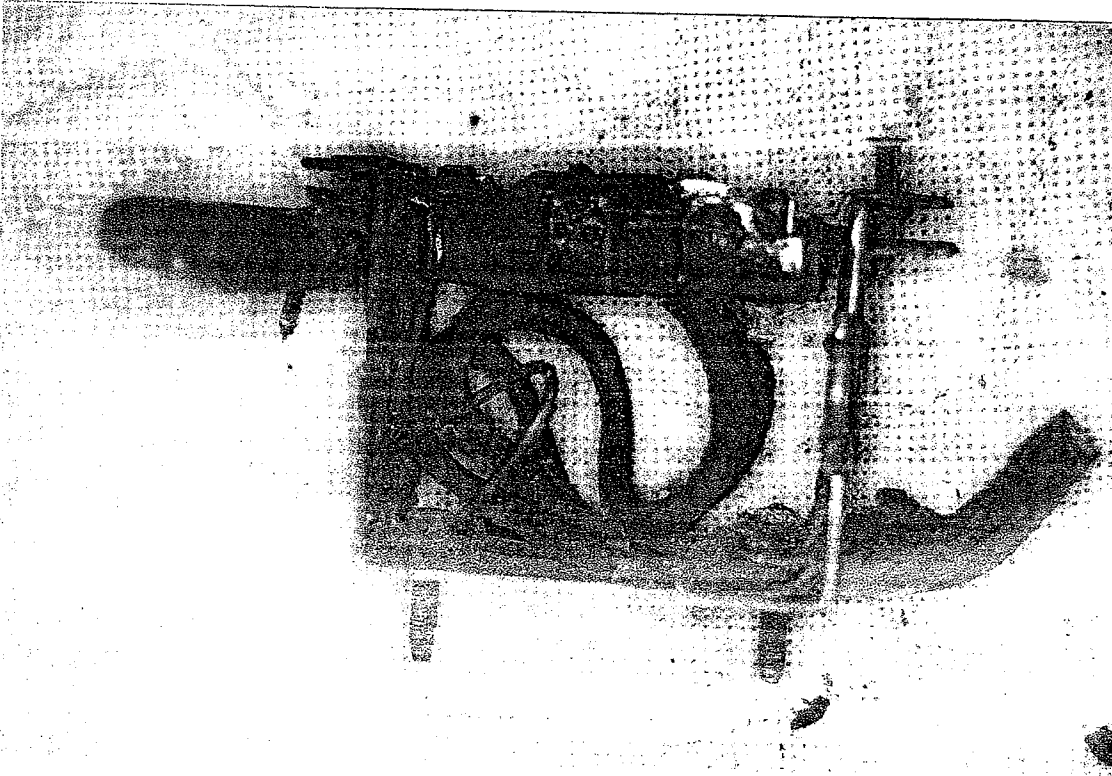
No.: 3

Wiring and Receptacle - These were examined for any electrical defects that could have contributed to the loss. No abnormalities or defects were found.

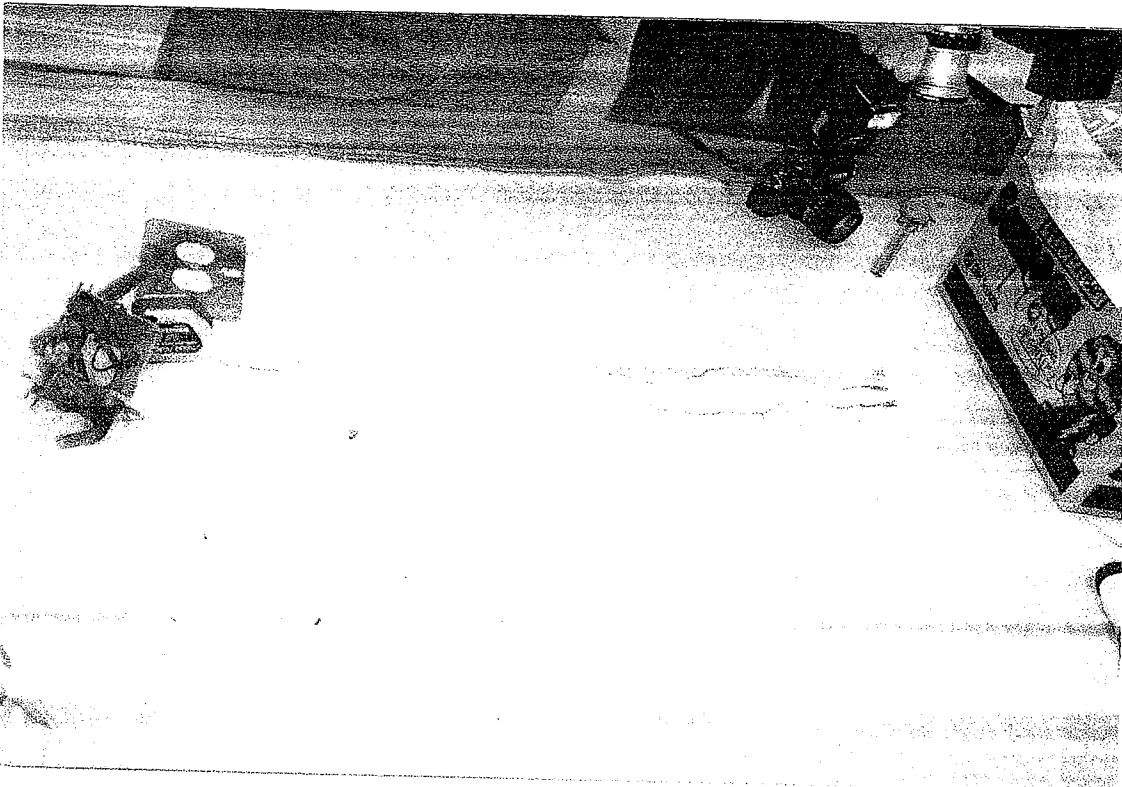
No.: 4

Evidence taken from the loss scene also included the wall receptacle that the toaster was plugged into and a 27-inch (approximate) length of zip cord of unknown origin with its insulation burned off.

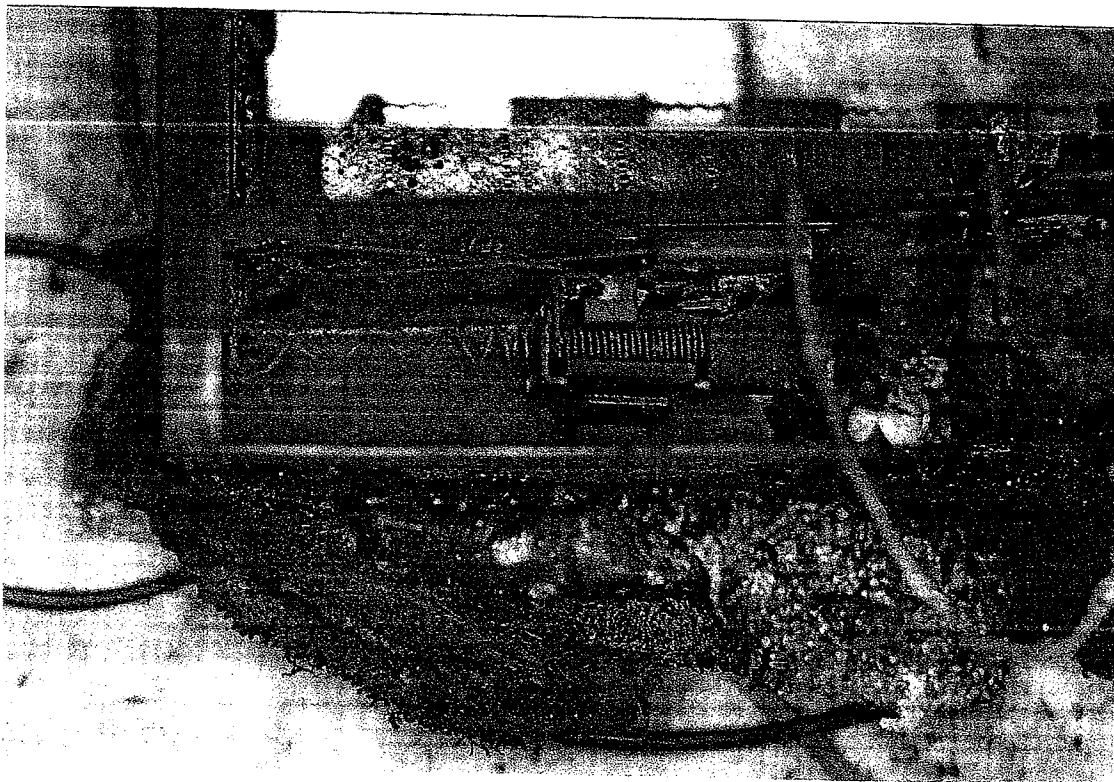
No.: 11

- The ejection mechanism had been released by the solenoid but was in essentially the full down position.
- The first six coils of the ejection spring were damaged severely (stretched and distorted) and this greatly reduced the energy that could be stored in the spring.
- The coils were damaged because the spring was not centered in the hole that allowed it to pass through an opening on a metal portion of the movable ejection mechanism. It was rubbing against the edge of the metal mechanism. The metal edge got caught in between the spring coils when the spring was in the up position. Pushing down on the external slide lever just stretched the first six coils of the spring without stretching any of the remaining spring coils.

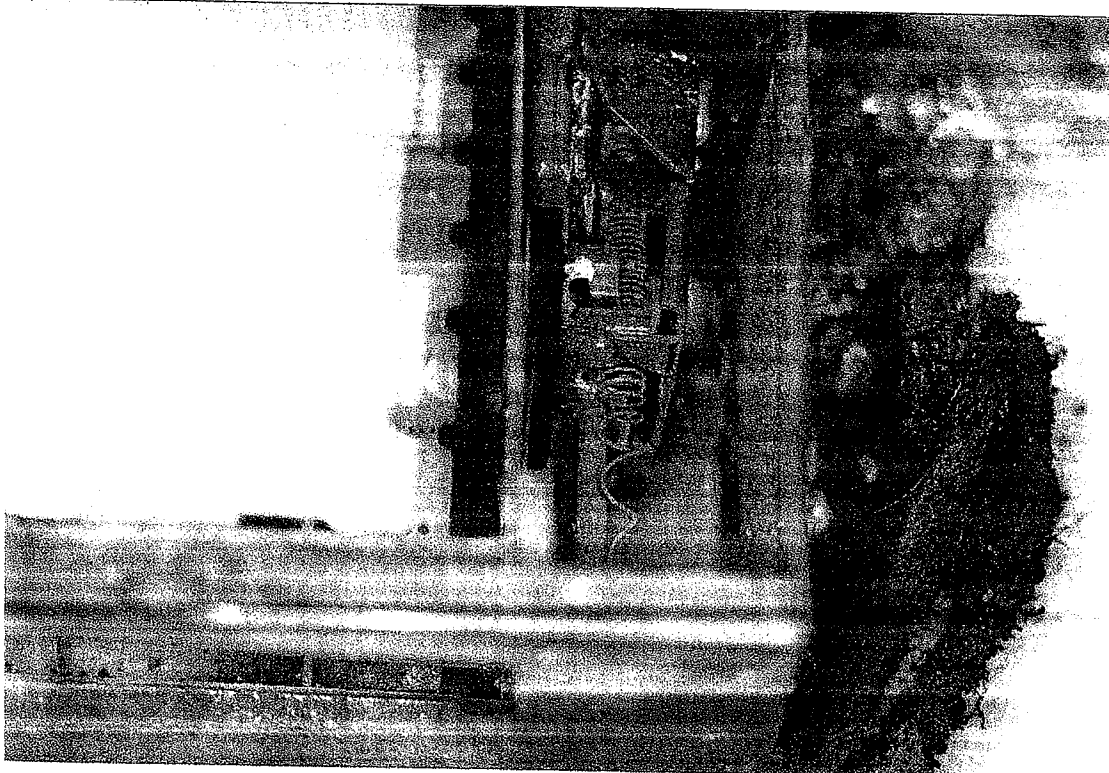
No.: 12page 6 of 6

The result of the above failure scenario was that the Pop-Tart didn't eject and the toaster heater coils remained on. This allowed the temperature inside the toaster to rise to a level sufficient to ignite the Pop-Tart. The fact that the spring coils caught on the metal edge was due to a manufacturing or design defect in the toaster that allowed the spring to become off center in normal use to the point where it eventually got caught by the metal edge.
